# Manhole Inspection Summary

Manhole # S71U\_\_012MH

Insp Date: **12/8/08 2:18 PM**

**Location** Address: **6642 Holabird Ave.**

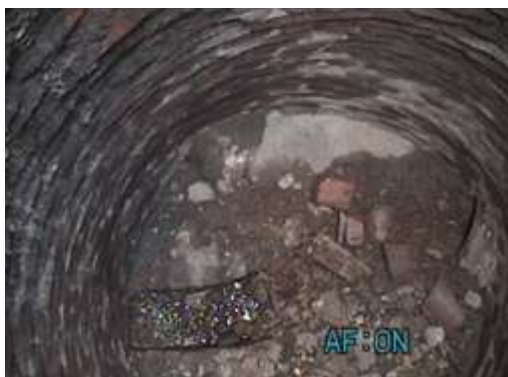
**Full of debris. Cleaning required.**

debris blocks channel from I5

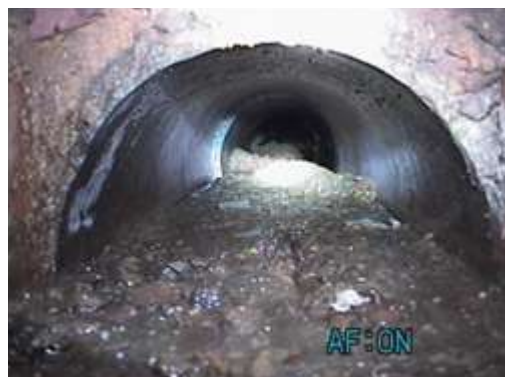
Defect 2

Debris filled outgoing 12

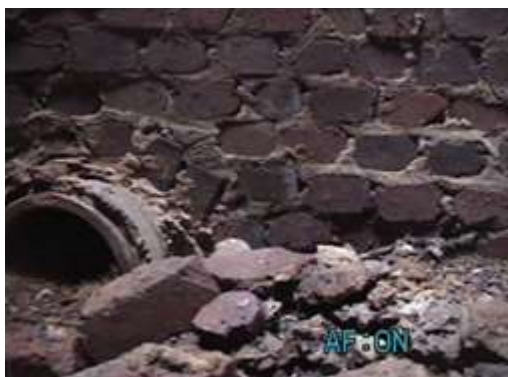
Defect 3

Condition: ☐ Sound ☐ Cracked ☐ Root Intrusion ☒ **Deteriorated** ☐ Leaks ☒ **Debris**

Debris of bench and channel

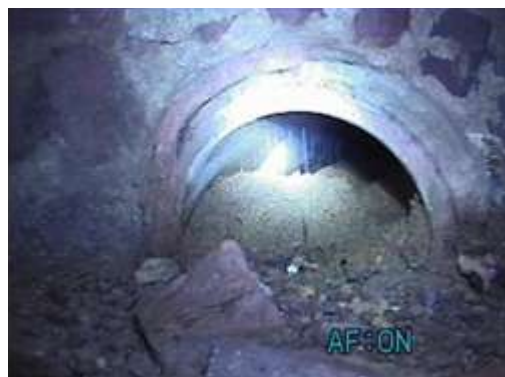
Defect 1

Cracked pipe seal I-5. 10:00-1:00

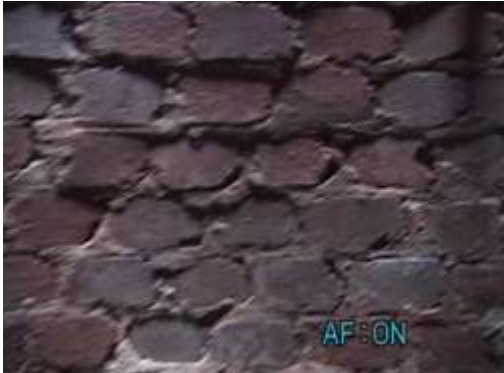
Defect 4

Condition: ☐ Sound ☐ Cracked ☐ Root Intrusion ☒ **Loose Brick** ☒ **Deteriorated**

Infiltration: ☐ None ☒ **Joint** ☐ Cracks ☒ **Mortar** ☐ Roots ☒ **Wall**

Mortar and joints defect barrel

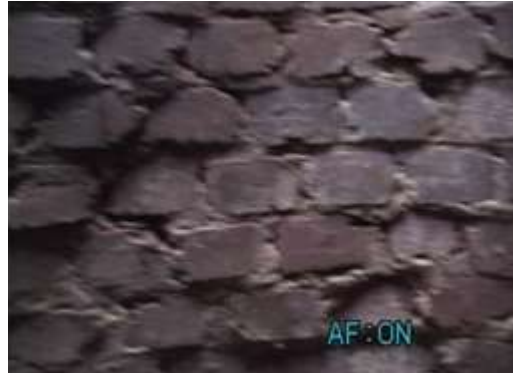
Defect 5

Condition: ☐ Sound ☐ Cracked ☐ Root Intrusion ☒ **Loose Brick** ☒ **Deteriorated**

Infiltration: ☐ None ☒ **Joint** ☐ Cracks ☒ **Mortar** ☐ Roots ☒ **Wall**

Mortar and joints deterioration corbel

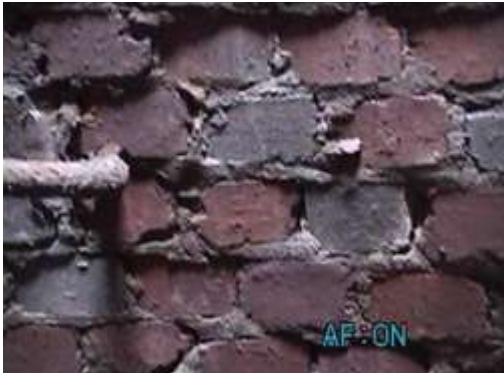
Defect 6

wall deterioration by step

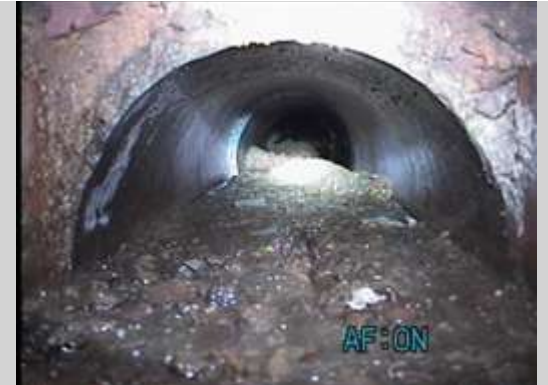
12 O'Clock Outflow

Pipe Height: **8.4** (in.) Rod and Bar (Angled)  
Pipe Material: **Clay** ☐ Pipe Lined  
Invert Depth: **9.92** (ft.) Flow Characteristics: **Slow**  
Deposits: ☐ None ☒ **Mud** ☐ Sludge ☒ **Debris** ☐ Grease  
Silt Depth: **3** (in.) Deposits Extent: **Medium**  
Infiltration: **None** Pipe Seal Cond: **Sound**

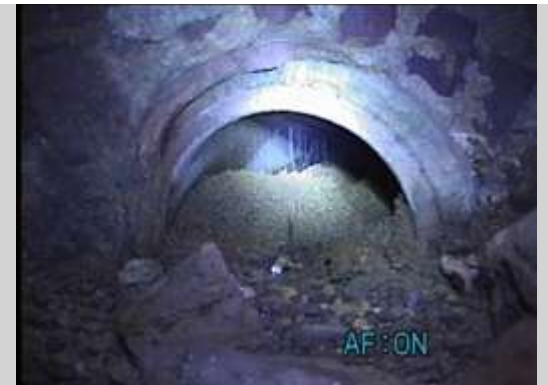
5 O'Clock Inflow

Pipe Height: **8.4** (in.) Rod and Bar (Angled)  
Pipe Material: **Clay** ☐ Pipe Lined  
Invert Depth: **9.42** (ft.) Flow Characteristics: **None**  
Deposits: ☐ None ☒ **Mud** ☐ Sludge ☒ **Debris** ☐ Grease  
Silt Depth: **5** (in.) Deposits Extent: **Heavy**  
Infiltration: **Evidence** Pipe Seal Cond: **Cracked**
